CIVIL ENGINEERING LABORATORY
Naval Construction Battalion Center
Port Hueneme, California 93043

6 REDUCING VANDALISM IN NAVAL BACHELOR ENLISTED
QUARTERS, VOLUME II: DEMONSTRATION PROGRAM &
DESIGN GUIDELINES. and

BOSTI
THE BUFFALO ORGANIZATION FOR SOCIAL &
TECHNOLOGICAL INNOVATION
Buffalo, New York

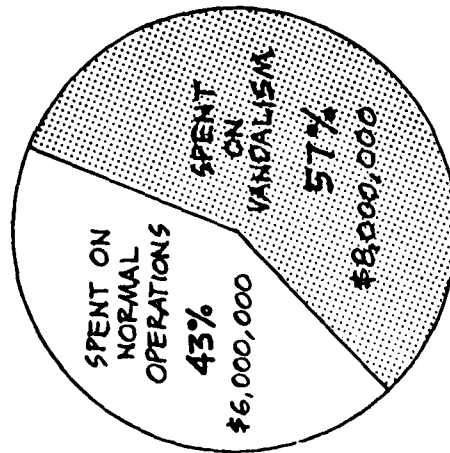
VANDALISM COST AS A PERCENTAGE OF TOTAL BEQ MAINTENANCE, REPAIR AND OPERATIONS BUDGET

For 1976, the estimated cost of these incidents to the Navy is almost \$8,000,000. The estimated 1976 budget for maintenance, repair and operations of stateside BEQs is almost \$14,000,000. Thus, as is shown in the diagram to the left, over half (57%) of the budget for BEQ operations during that period is believed to have been spent repairing property damage due to vandalism.

1. Well over half (57%) of the Navy-wide costs for BEQ maintenance and operations reported to us during 1976 have been spent repairing, reporting and investigating property damage due to vandalism.
2. At the current rate of vandalism, vandalism costs for FY 1978 and 1979 are equal to 48% of the total projected Navy Construction Program budget (excluding overseas and marine installations) for FY 1978 and FY 1979.

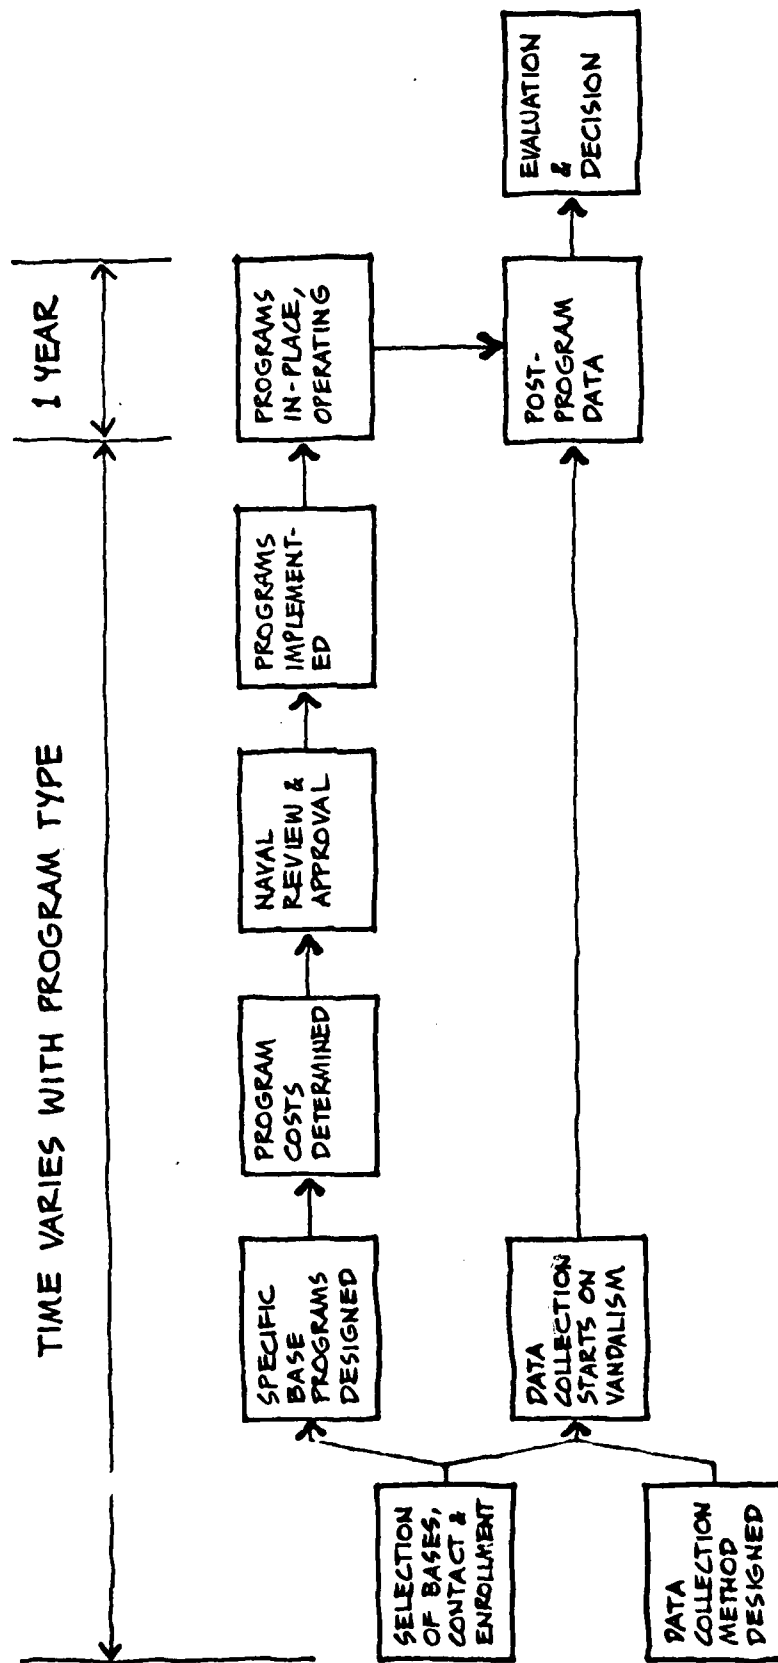
GROSS TASK MODEL FOR ALL 4 DEMONSTRATION PROGRAMS

Following the diagram are the more detailed discussions of the demonstration projects and the evaluation methodology which were previously mentioned.

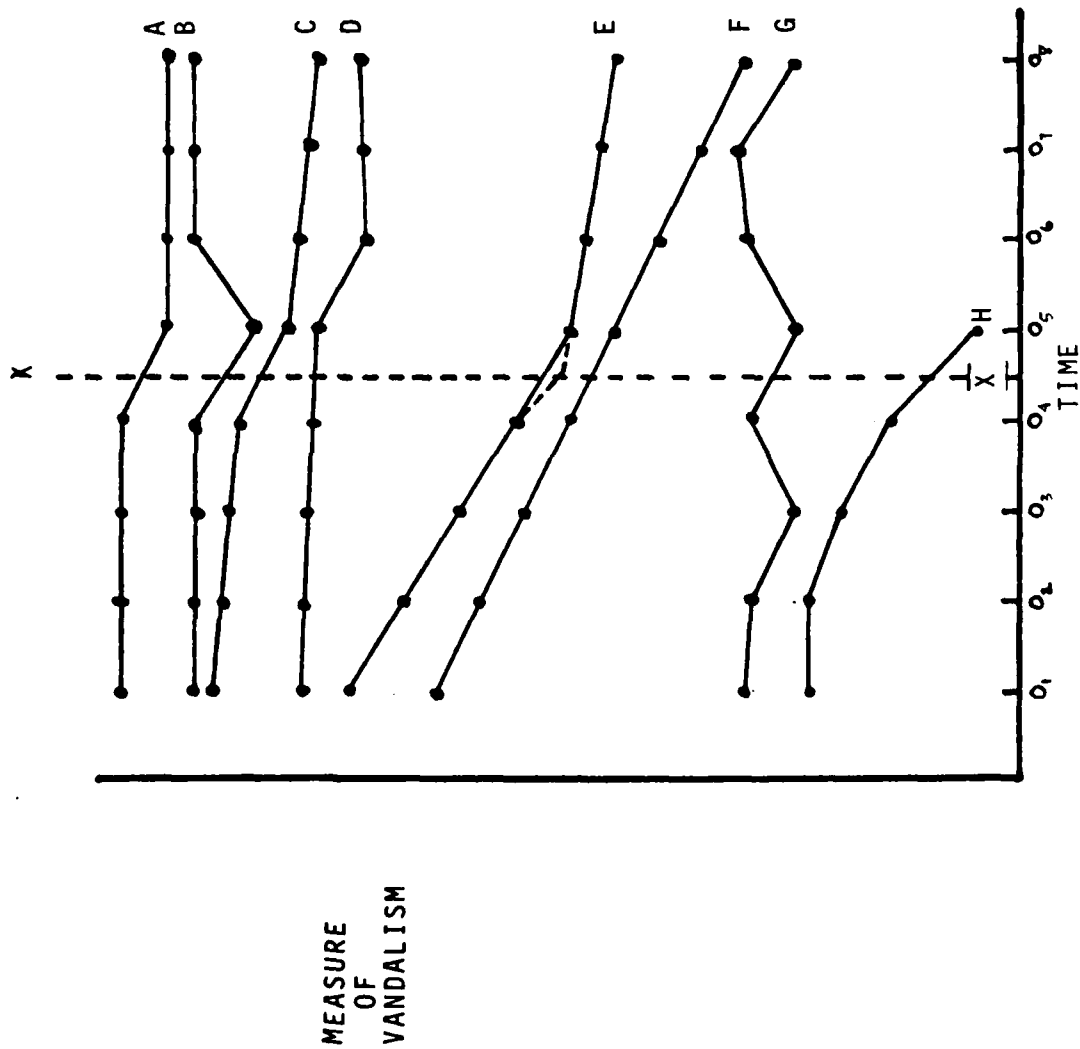
The figure below indicates some possible outcome patterns for a time-series which may occur after a design change has been introduced as indicated by the vertical line X.

From this figure, it can be inferred that X has had some effect on the measured observations on lines A and B and possibly C, D and E, but that lines F, G and H were not affected by the treatment, X.
